MARYLAND INVENTORY OF HISTORIC BRIDGES HISTORIC BRIDGE INVENTORY MARYLAND STATE HIGHWAY ADMINISTRATION/MARYLAND HISTORICAL TRUST

MHT	No.	B-4630

SHA Bridge No. BC 4502 Bridge name Mannasota Avenue over Herring Run
LOCATION: Street/Road name and number [facility carried] Mannasota Avenue
City/town Baltimore Vicinity
County Baltimore
This bridge projects over: Road Railway WaterX Land
Ownership: State County Municipal X Other
HISTORIC STATUS:  Is the bridge located within a designated historic district? Yes NoX  National Register-listed district National Register-determined-eligible district  Locally-designated district Other
Name of district
BRIDGE TYPE: Timber Bridge: Beam Bridge: Truss -Covered Trestle Timber-And-Concrete
Stone Arch Bridge
Metal Truss Bridge
Movable Bridge: Swing Bascule Single Leaf Bascule Multiple Leaf Vertical Lift Retractile Pontoon
Metal Girder:  Rolled Girder:  Rolled Girder Concrete Encased  Plate Girder:  Plate Girder Concrete Encased
Metal Suspension
Metal Arch
Metal Cantilever
Concrete X : Concrete Arch X Concrete Slab Concrete Beam Rigid Frame

B-4630 Bridge BC 4502 Mannasota Avenue over Herring Run Baltimore City

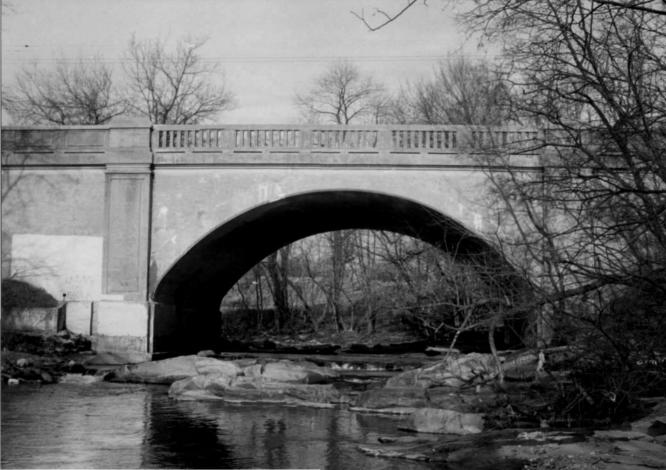
Inventory # \_ B - 4636

Name 4502- MANNASOTA AVE OVER HERRING RYN County/State BALTIMORE CITY/MD
Name of Photographer TIM SCHOEN
Date 1/95
Location of Negative SHR
Description EAST ELEVATION
Number $\frac{\cancel{\cancel{4}} \text{ of } \cancel{\cancel{5}} \cancel{\cancel{5}}}{\cancel{\cancel{5}}}$

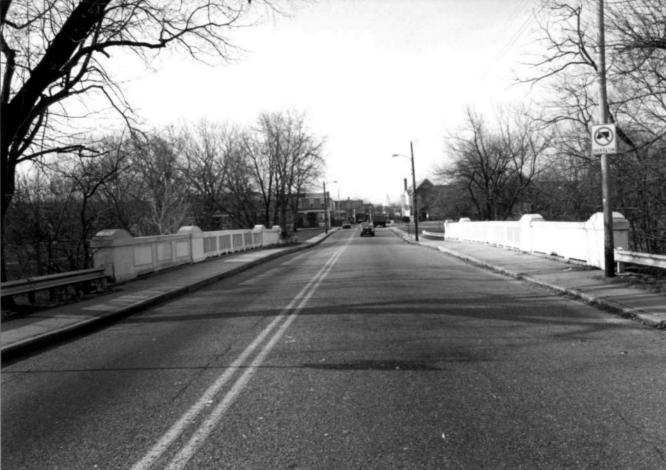
Inventory # <u>B-4630</u>

Name 4502 MANNASOTA AVE OVER HERRING R County/State BALTIMORE CITY/MO	Jur
Name of Photographer TIM SCHOEN	
Date 1/95	
Location of Negative SHA	
Description NORTH APPROACH	
Number 8 of 26 5

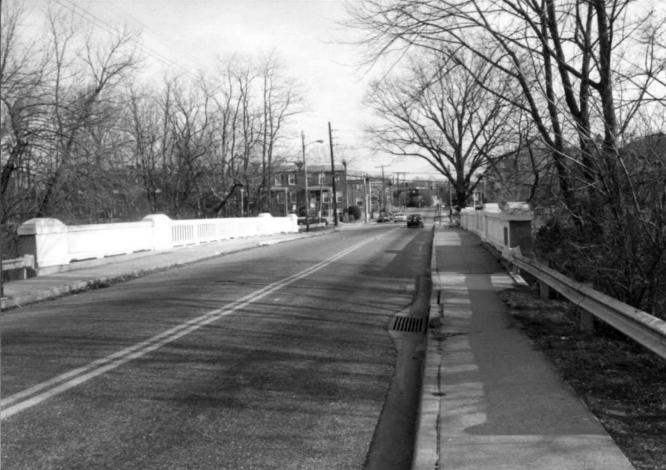
## Inventory # <u>B-4630</u>

Name 4502 - MANNASOTA AJE OVER HERRING
County/State BALTIM ORE CITY/MD RUN
Name of Photographer TIM SCHOEN
Date1 95
Location of Negative SHA
Description South APPROACH
Number 16 of 36 5

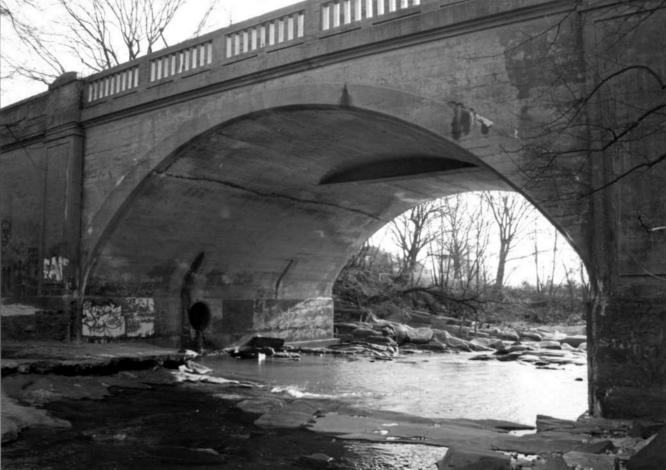
# Inventory # <u>B-4630</u>

Name 4502-MANNASOTA NE UVER HERRING RUN
County/State BALTIMORE CITY IMD
Name of Photographer TIM SCHUEN
Name of Photographer TIM SCHUEN  Date 195
Location of Negative SHA
Description WEST ELEVATION
1
Number 7 of 36 5
Number 1 of 20
